Draft guidance for the planning of new MRI installations

February 2026

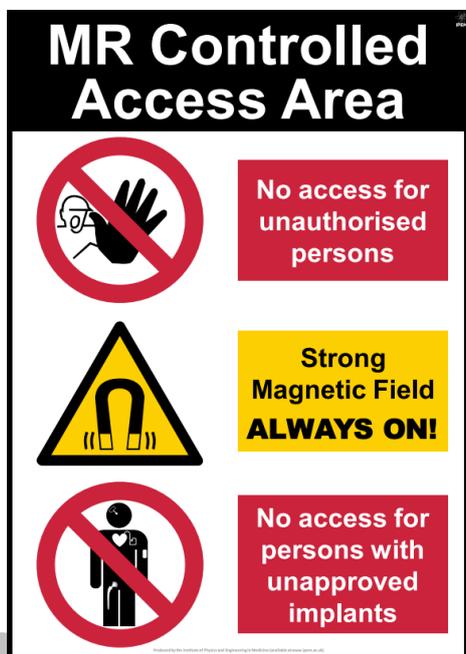
880
881
882 *Figure 7. [MR Controlled Access Area](#) signage from the IPEM MRI warning signage templates.*

873 Ideally, all patient and staff entry points to the [MR Controlled Access Area](#) should incorporate self-
874 closing, self-locking doors, although access must be immediately available in the event of a power
875 outage. Each entry to the [MR Controlled Access Area](#) should have warning signs on display. IPEM
876 offer freely available MRI warning signage templates ([IPEM 2017](#)) that include examples for entry
877 points to the [MR Controlled Access Area](#) such as that shown in Figure 7.

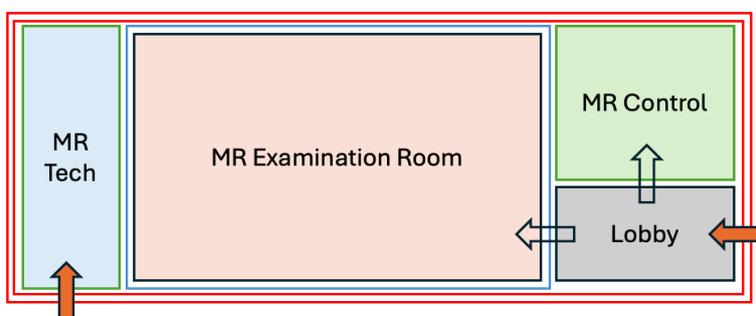
Two example layouts for fire compartmentalisation are shown below in Figure 8.

= Fire Rated Construction Enclosing MR Zone

= Fire Rated Doors

Figure 8. Two example layouts for fire compartmentalisation.

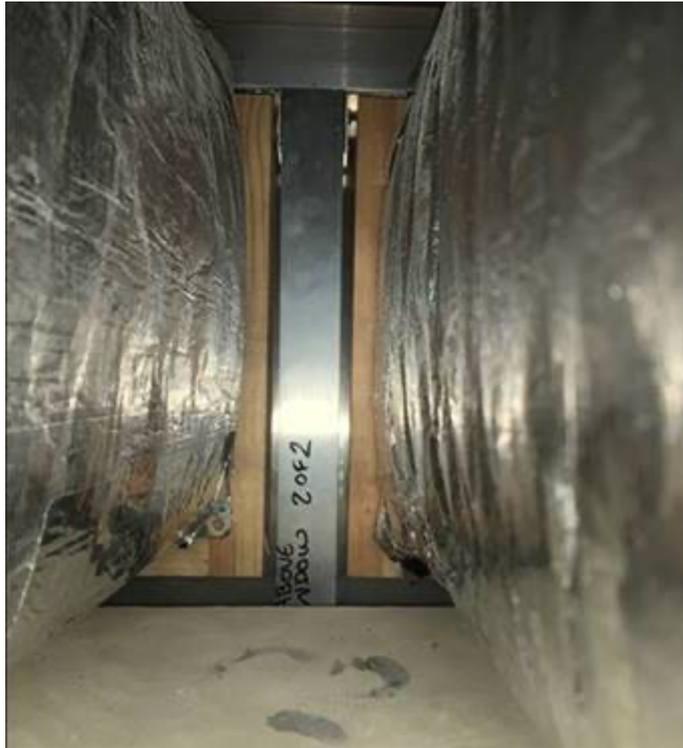
Figure 9. Example of wooden frame providing electrical isolation between honeycomb waveguides in the RF cage and external air ducting.

1463 To ensure electrical isolation between honeycomb waveguides in the RF cage and external air
1464 ducting, a non-conducting packing material, e.g. wood, should be used, as shown below in Figure 9.
1465 Mechanical vibration is known to be another potential source of RF interference. Consequently, a
1466 degree of mechanical isolation between the RF cage and any attached structures (e.g. ducting, pipes)
1467 is desirable to reduce the possibility of vibrations being transmitted onto and into the RF cage.

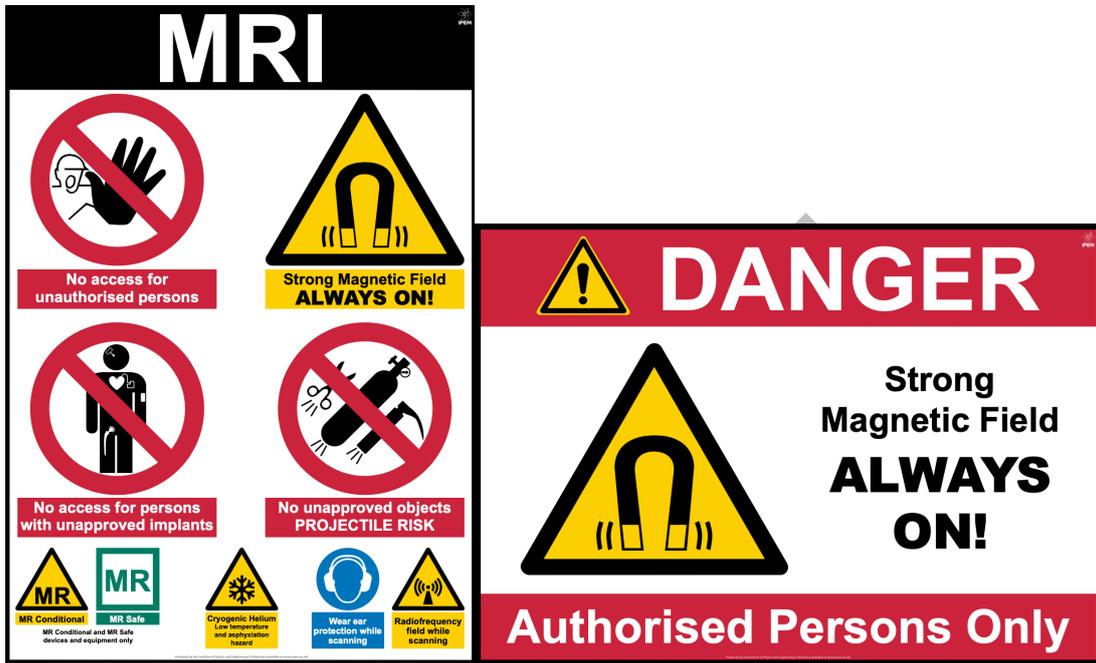
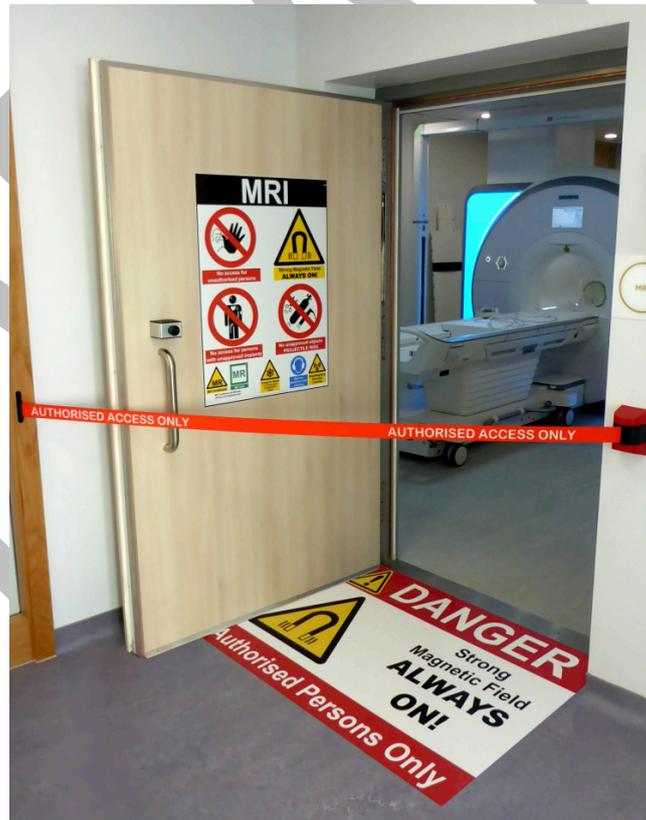
Figure 10. IPEM door and floor warning signs (IPEM 2017) and an example of both in practice, additionally demonstrating a second copy of signage on the inside of the door to maintain a visible warning sign when the door is open

The MR Examination room door should have clear signage indicating the hazards in the MR Examination room. Immediately outside of the MR Examination room door it is helpful to incorporate floor signage to highlight that the magnetic field is always on, as well as a retractable belt barrier that can be used to further provide access control as required. A mains-powered illuminated “The magnet is always on” sign with integrated battery backup may be placed above the

1494 MR Examination room door, although consideration should be made for an appropriate schedule for
 1495 preventative maintenance. Examples of all of these are shown below in Figure 10.
 1496
 1497

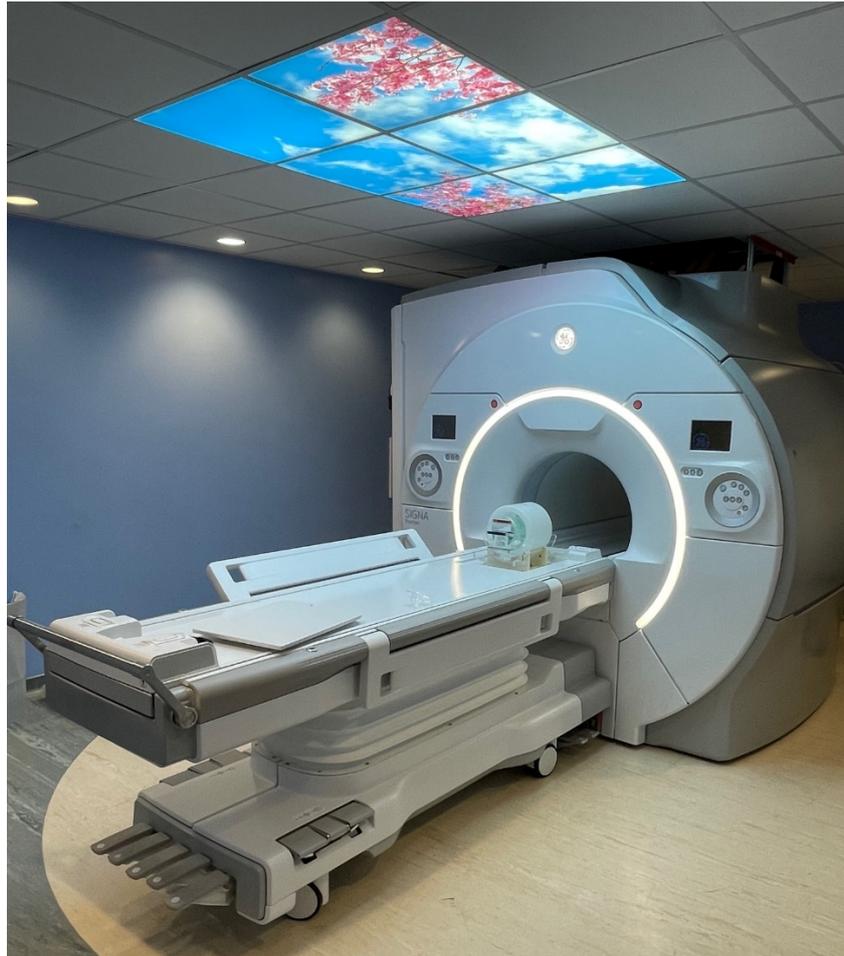
Figure 11. Example of artificial skylight designed for use in the MR Examination room that may be considered to improve the patient experience of an MRI scan.

1655
1656
1657 Finally, artificial skylights or illuminated wall panels should be considered to improve the patient
1658 experience, although again these should be designed to work in an MR Examination room without
1659 causing RF interference. An example of such a skylight is shown below in Figure 11.
1660

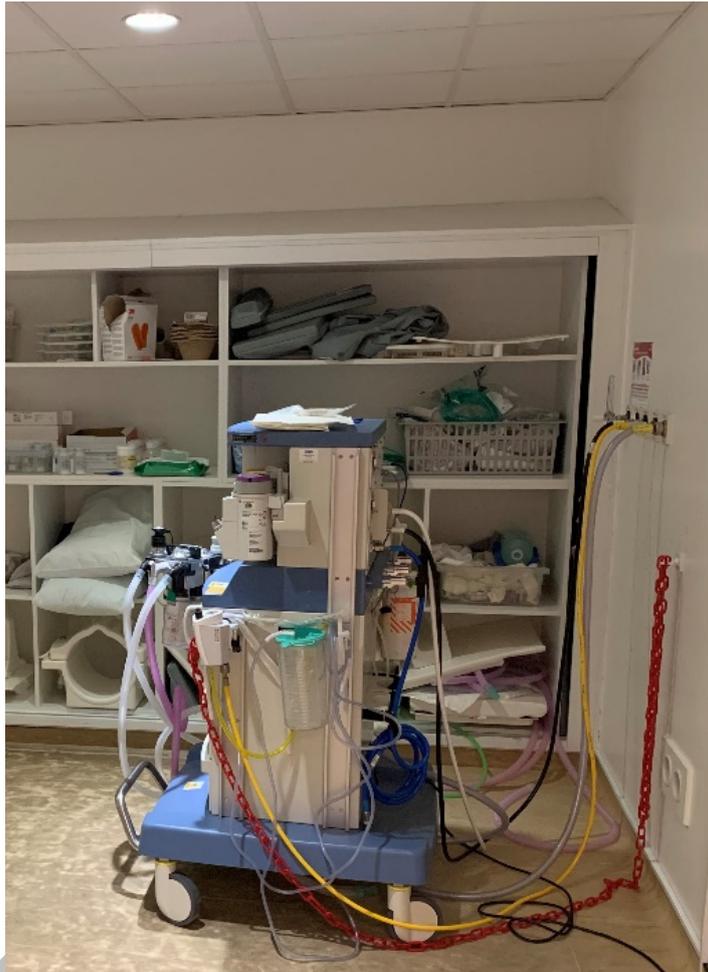
1698
1699 Additionally, the fitting of anchor points in the walls inside the MR Examination room with fixed-
1700 length tethers should be considered to help ensure such [MR Conditional](#) equipment is not
1701 inadvertently moved closer to the MR scanner and into a higher magnetic field than is specified on
1702 the [MR Conditional](#) labelling. The fitting of these and any other wall fixations must be carefully
1703 planned to avoid inadvertently penetrating the RF cage. An example of wall anchor points is shown
1704 below in Figure 13.
1705

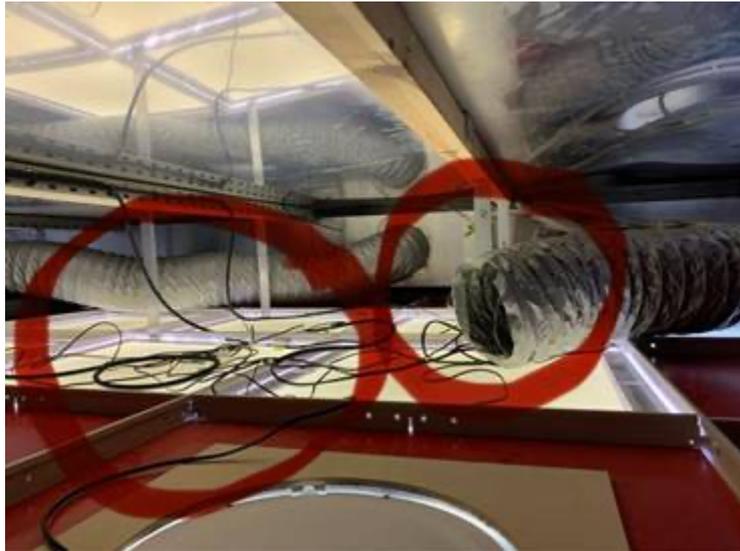
- Avoidance of any loose metal connections, since these can produce discharges of RF interference, appearing as RF spike artefacts on the MR images and degrading diagnostic quality. The suspended ceiling should be fixed. Suspension via movable clamps or springs should be avoided. Similarly, any cabling in the ceiling void should be fixed to appropriately secure cable trays and mounting brackets. Loose cables trailing on the suspended ceiling within the RF cage as demonstrated in Figure 21 are known to be a source of RF spikes and should be avoided.

Figure 21. Loose cables trailing on the suspended ceiling within the RF cage are known to be a source of RF spikes and should be avoided by use of secure cable trays and mounting brackets.

Figure 17. Examples of quench pipe outlet designs.	71
Figure 18. MRI quench pipe outlet warning signage from IPEM MRI safety notices.	73
Figure 19. Example of MRI supporting plant. The air handling unit is highlighted by the yellow dotted box. Also shown is the condenser unit for the MR Examination room air conditioning and the MR chiller system that provides chilled water to the MR system heat exchanger located in the equipment room. The red dotted line partially shows the magnet access. This wall is demolished for installation/removal of the magnet.	77
Figure 20. Example RF cabin results, showing the shielding effectiveness at 30 MHz, 63 MHz and 128 MHz, demonstrating all results were greater than 100 dB.	90
Figure 21. Loose cables trailing on the suspended ceiling within the RF cage are known to be a source of RF spikes and should be avoided by use of secure cable trays and mounting brackets.	92

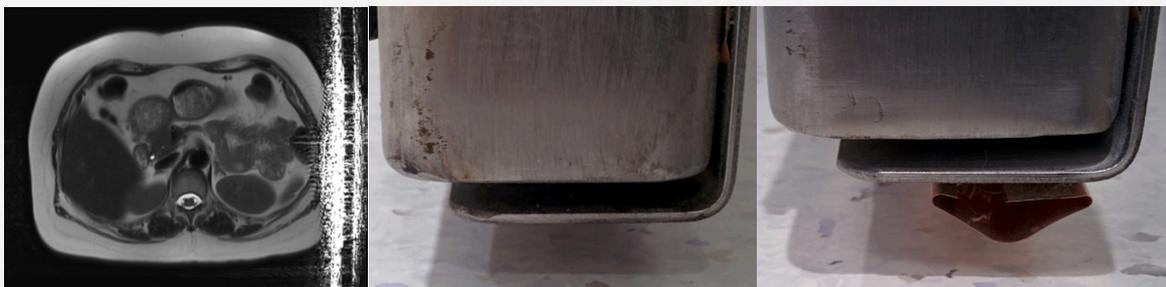
Two 3T MR scanners were installed with a shared MR control room. Although the MR scanners were ramped up with the appropriate separation of centre frequencies, intermittent external RF interference was observed on MR images with high receiver bandwidths. It was subsequently identified that the metal strip at the base of the MR Exam room door that formed the electrical connection with the door frame was missing. This had been removed after the RF cage was built and commissioned to avoid potential damage to this strip during the rest of the building work, but reattaching this had been missed.

Impact: reduced MRI quality until RF leaves reattached on MR Examination room door.
